OCIM August 2024 Fatal Accident Analysis

Alan Crawford
Bozeman, Montana
USA

Summary

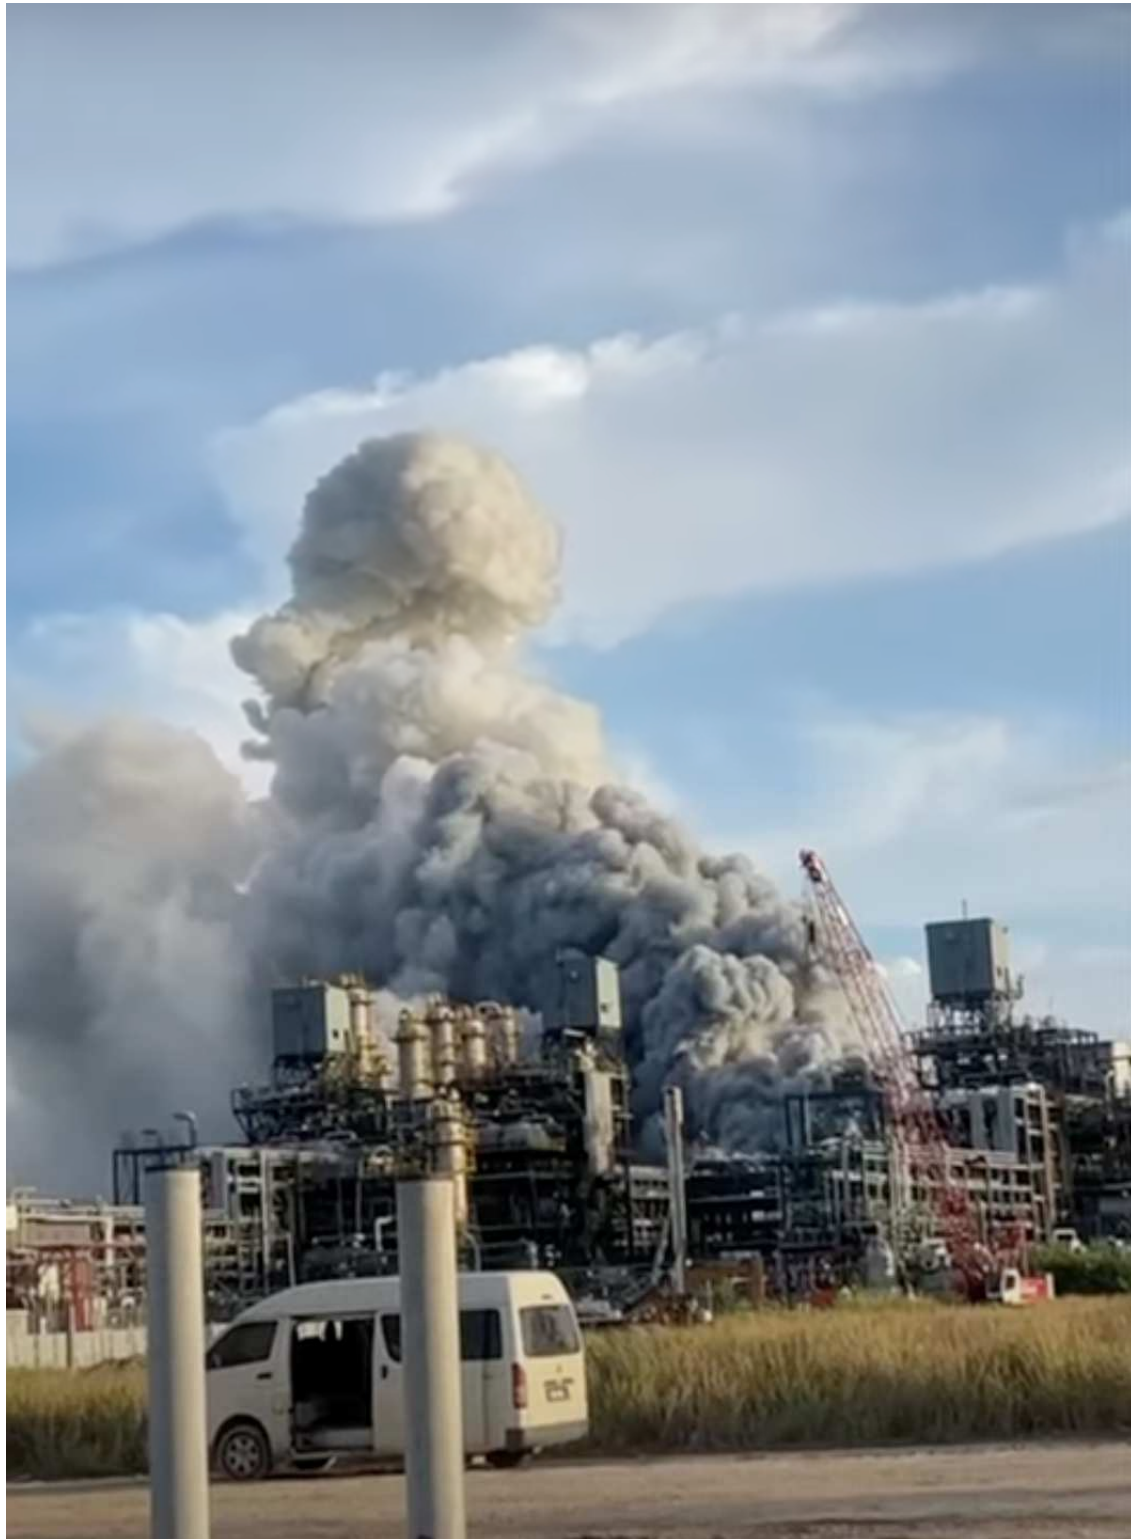
Figure 1: OCIM 14-August-2024 accident. The three units with top cubic enclosures are three hydrochlorination process units. These cubic enclosures likely contain the ground metallurgical grade silicon feed systems.

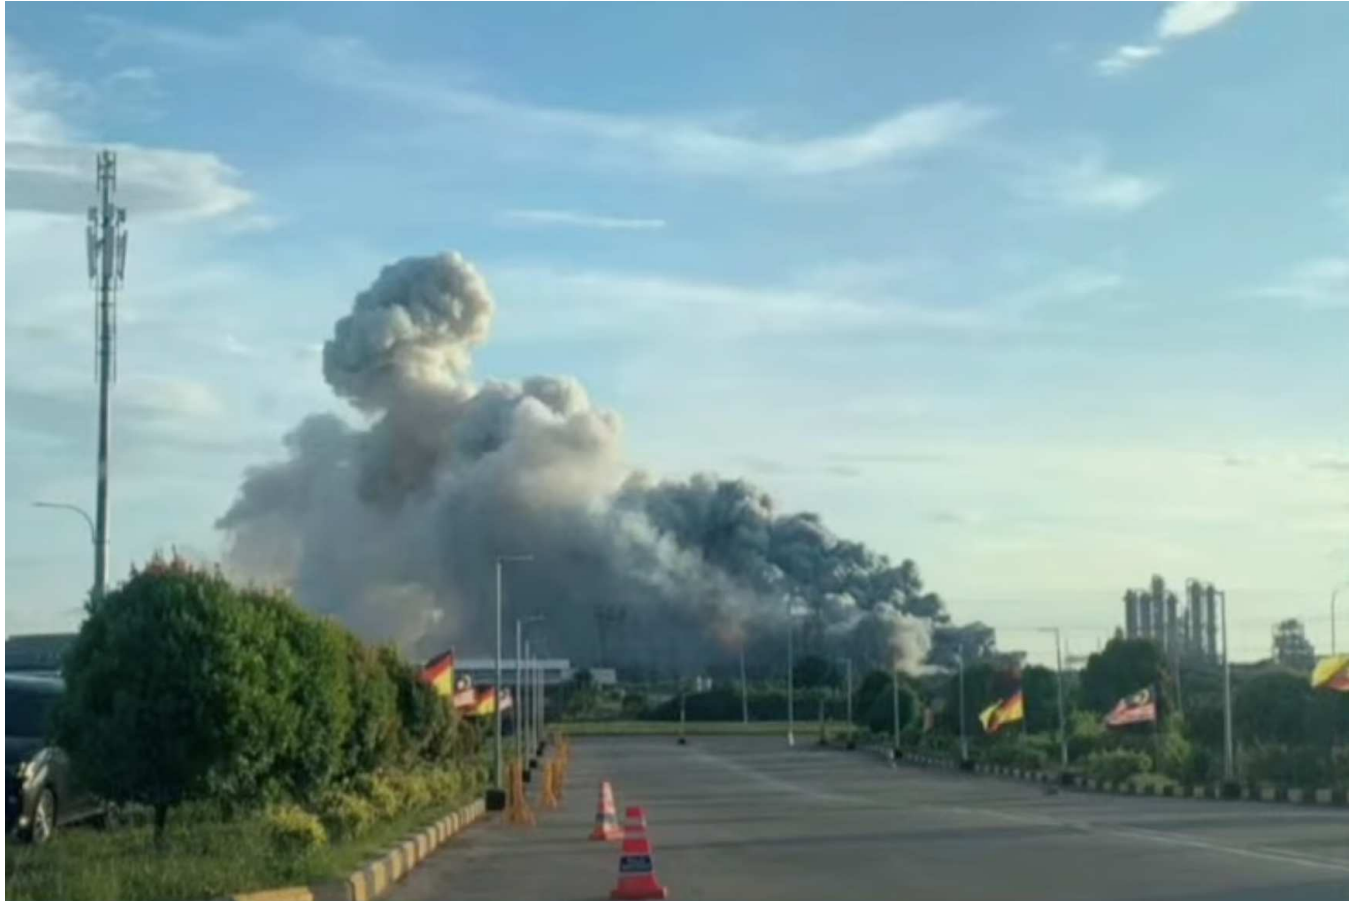
Figure 2: OCIM 14-August-2024 accident. This photo provides a perspective of the enormous size of the cloud. The only known polysilicon accident of similar magnitude is the July 2020 Xinjiang GCL incident.

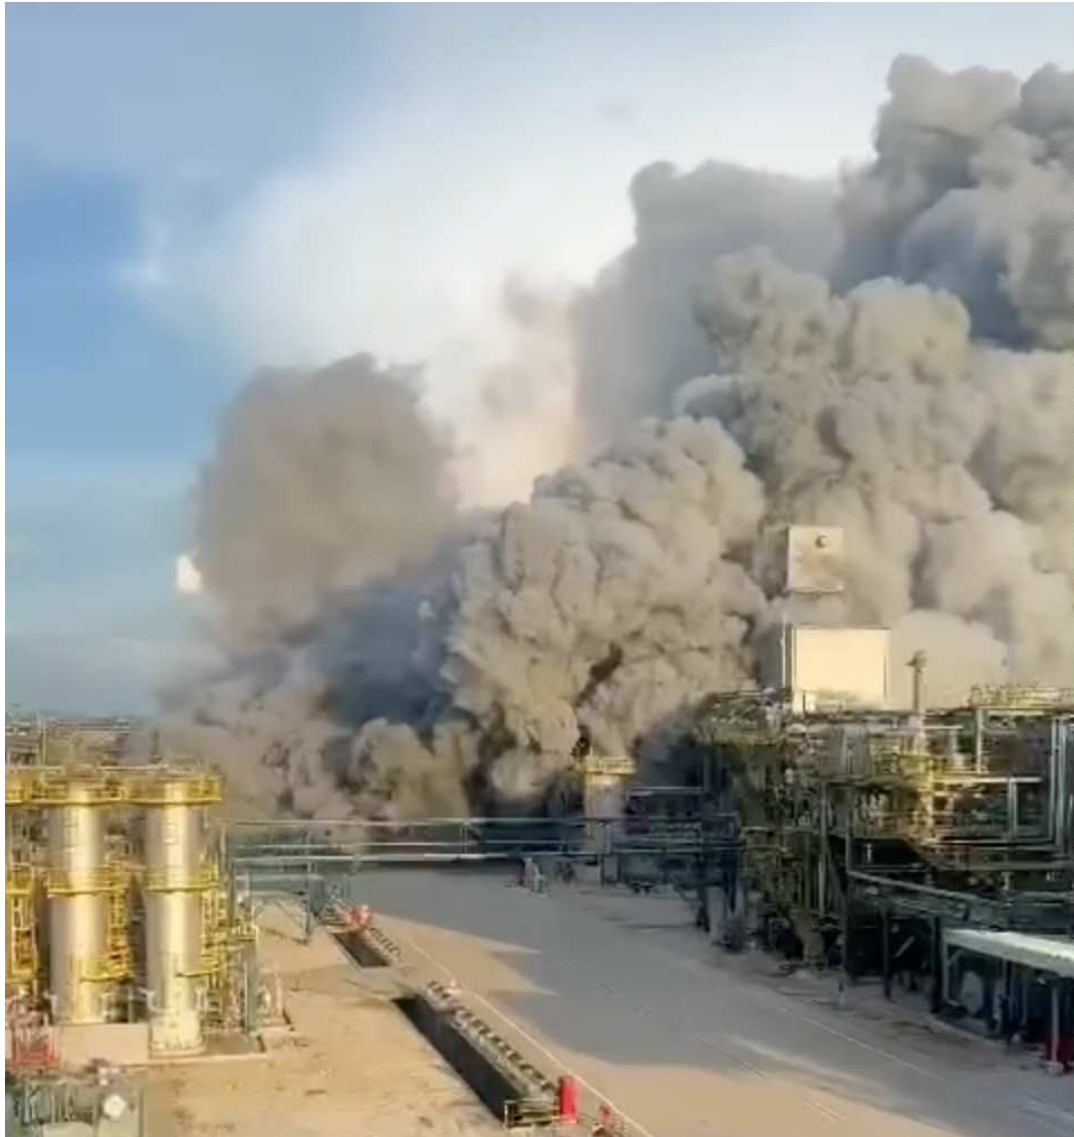
Figure 4: A screen grab from a video of the OCIM August 2024 fatal accident. Note the very dark color of the “cloud” which is indicative of high concentration of MGS powder. The process structures in this picture are clearly HC units (see discussion later in this section). There is no bulk MGS storage in this area.

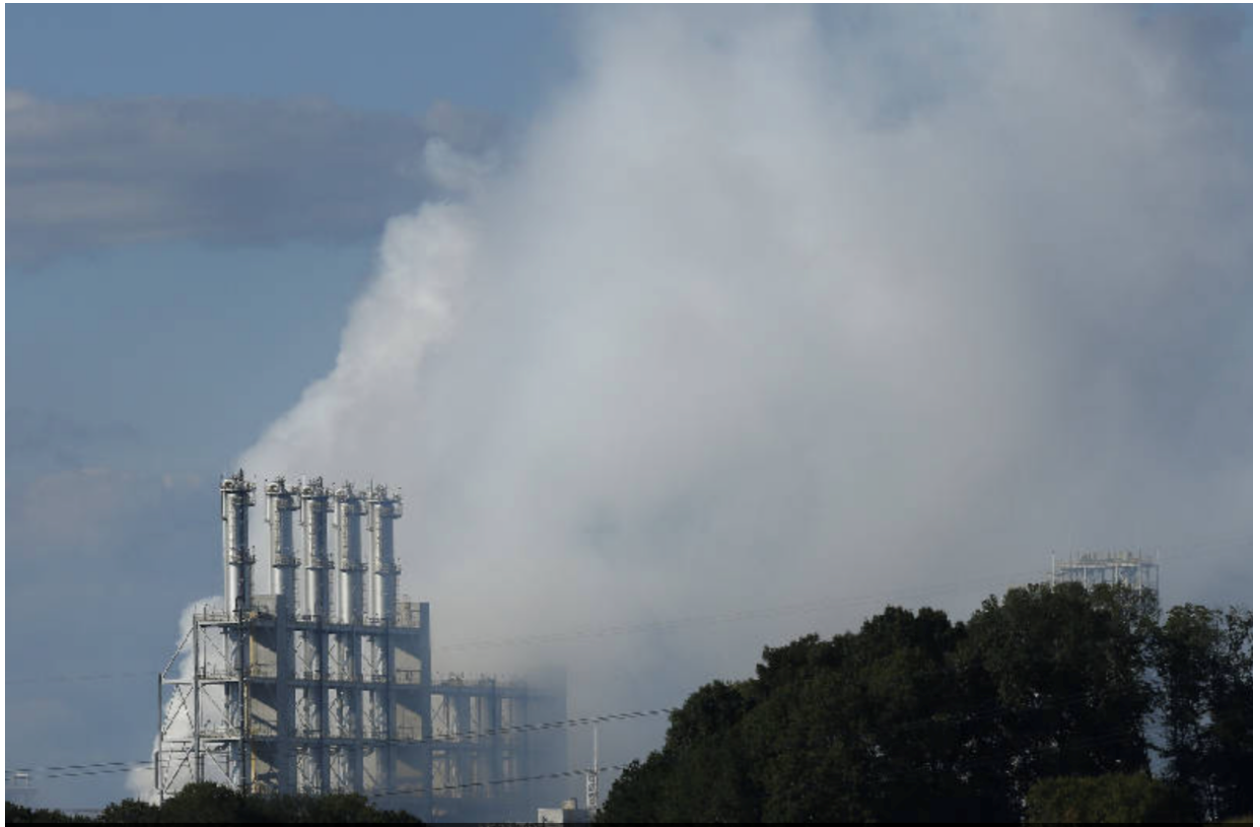
Figure 5: Photograph taken during a large chlorosilane release at the Wacker Polysilicon plant located in Charleston, Tennessee, USA on 7-September-2017. The white “cloud” is primarily HCl gas and a good example of a cloud resulting only from chlorosilane release. There were no serious injuries resulting from this accident. The accident was caused by a compressor failure.

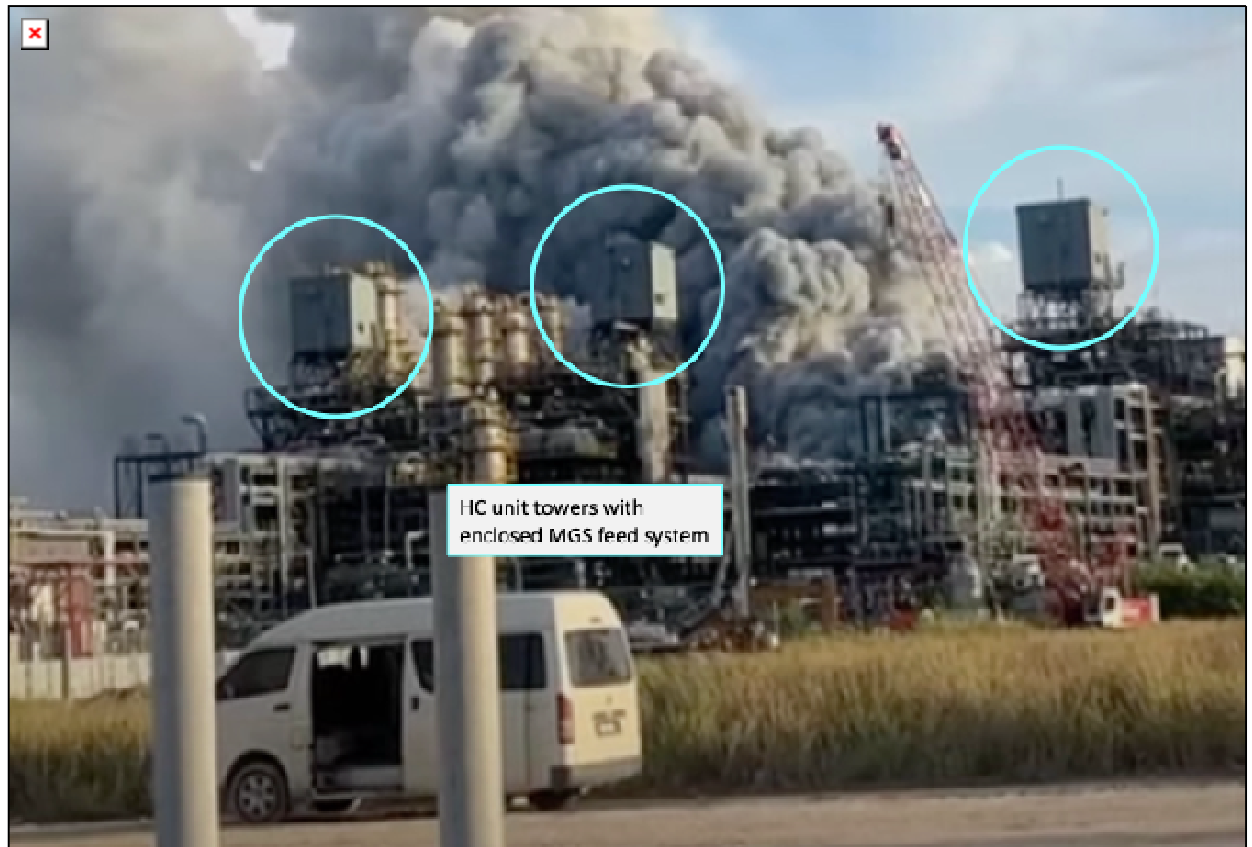
Figure 6: Cropped version of Figure 1 showing the large cloud of HCl and MGS originating at one (of three) HC process units at the OCIM site. There are three HC process units in this picture and each is marked by the distinctive enclosed MGS feed system which is the highest point of each unit. This enclosed MGS feed system located above the HC reactor is a distinctive feature of the specific HC technology used in these units.

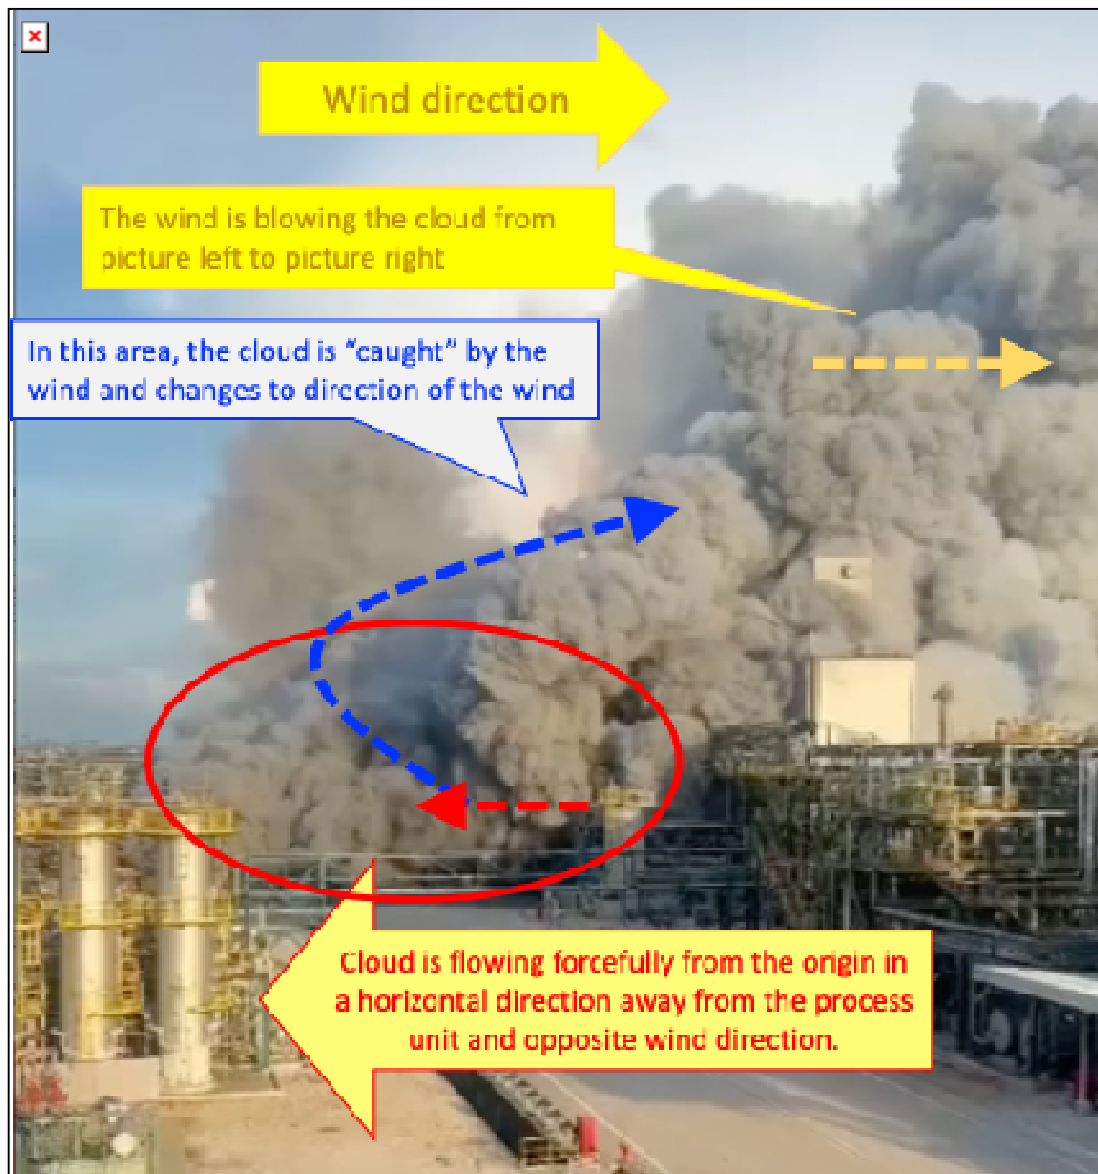
This horizontal movement away from the unit provides strong evidence that the failure occurred in a high-pressure part of the process. Prior analysis of which process unit and the location within the identified process unit (previous section of this report) shows the failure occurred within (or near) the HC fluid bed reactor process tower. The HC reactor and associated equipment is definitely a high-pressure part of the HC process. Specific operating conditions of the OCIM HC reactor is not known but likely in the range of 20 – 30 barg.

The dark gray color of the cloud is a definite indication that the failure occurred in a part of the process directly connected to the HC fluid bed reactor or even the reactor itself. This provides a very large “inventory” of reaction mass / MG-Si to discharge to the atmosphere. Experience also shows that when there is loss of pressure containment in a MG-Si containing section of any process, including HC, the high velocity discharge of gas and solids combined with the very abrasive characteristic of MG-Si usually increases the size of the original leak due to metal erosion.

Figure 7: Screen shot at the 11 second mark of a social media posted video of the OCIM August 2024 fatal accident. Analysis of how the “cloud” is moving is provided.

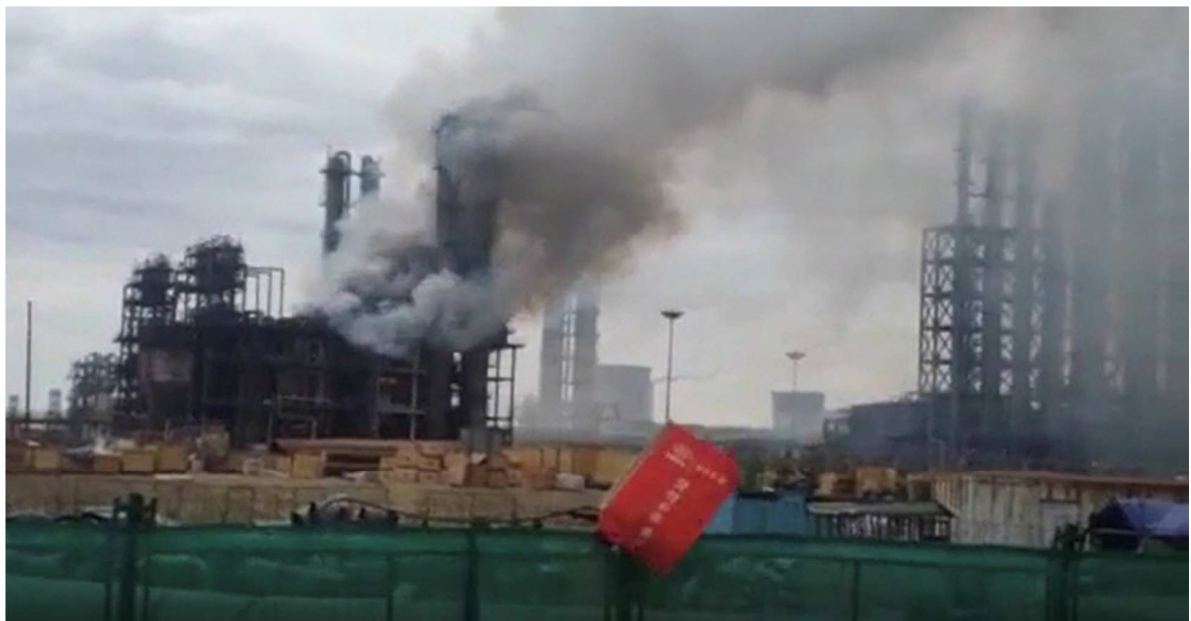
Another material that has been reported to be have been used is 347 Stainless steel (UNS S34700). East Hope (Xinjiang, China) is believed to have installed at least one HC FBR fabricated from 347SS in an effort to save CAPEX. The reactor was built by SunPower Group (See: <https://en.sunpowergroup.com.cn>). The reactor is reported to have “failed” in less than 3 years of operation. East Hope also experienced a significant process safety event on 17-June-2022 attributed to failure of a superheater. The superheater and associated piping is believed to have also been constructed of 347SS. A picture from this incident is provided in Figure 17.

Figure 17: Picture taken during 17-June-2022 East Hope (Xinjiang, China) process safety incident attributed to a superheated failure. See: <https://www.bernreuter.com/newsroom/polysilicon-news/article/fire-halts-polysilicon-production-at-east-hope-for-one-month/> .

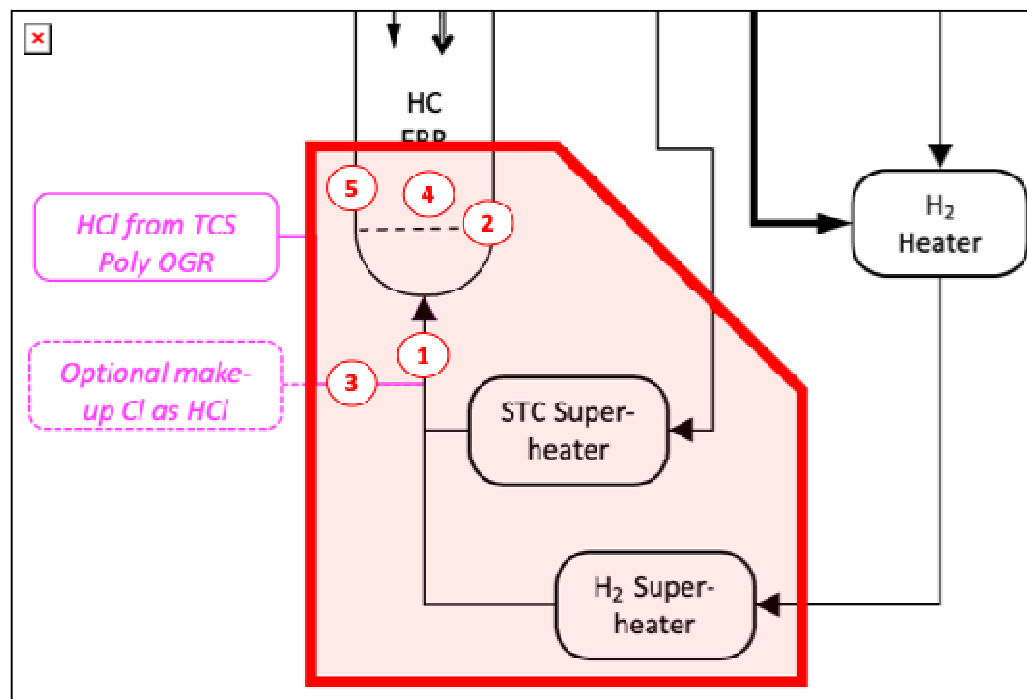
Figure 20: HC process unit with the four potential OCIM August 2024 fatal accident failure locations identified. Anhydrous HCl co-feed is mixed with main gas feed.

Failure of the main gas feed line to the hydrochlorination (HC) ($\text{Si} + 2\text{H}_2 + 3\text{SiCl}_4 = 4\text{HSiCl}_3$) fluid bed reactor (FBR) could easily result in the fatal accident experienced by OCIM in August 2024. Figure 20 and Figure 21 show the location of this pipe.

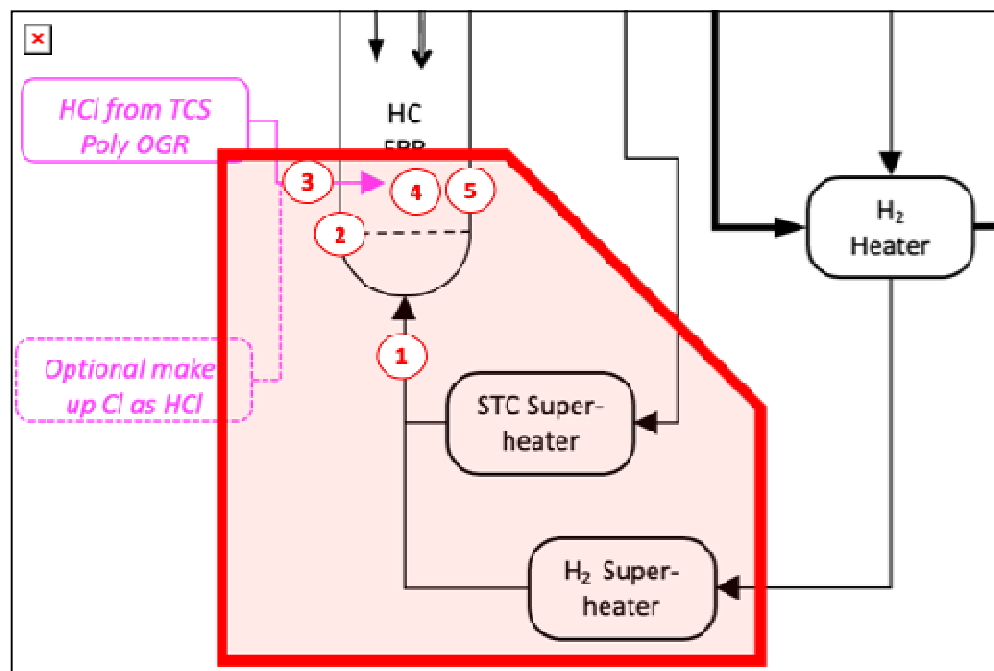
Figure 21: HC process unit with the four potential OCIM August 2024 fatal accident failure locations identified. Anhydrous HCl co-feed is injected into the reaction mass above the grid plate.

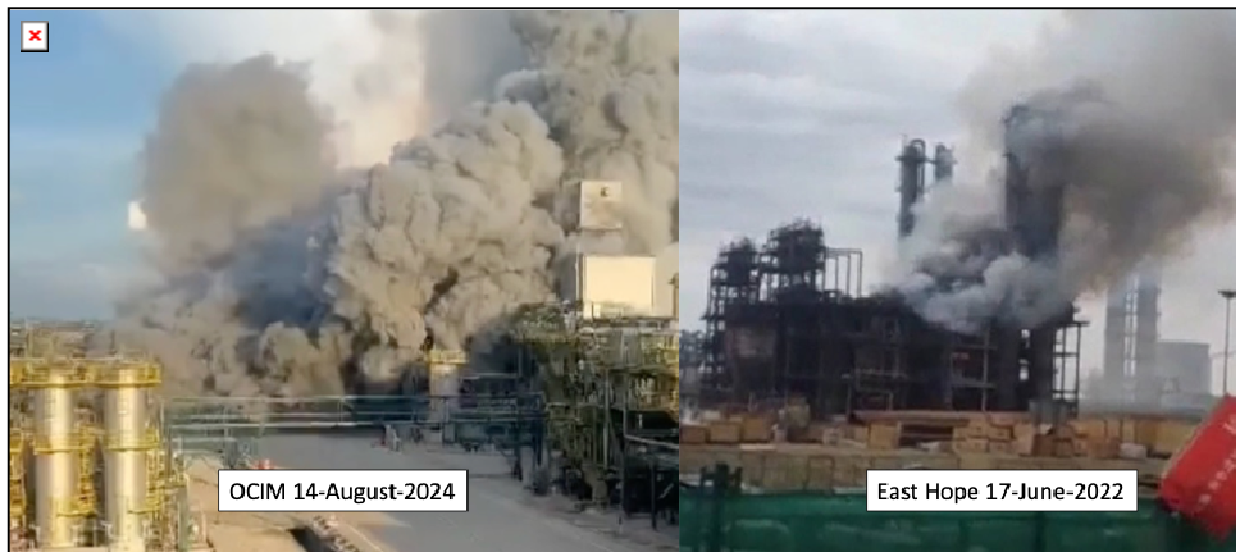
Figure 22: Comparison of cloud color from the OCIM August 2024 unspecified accident (image taken from Figure 4) and the East Hope June 2022 accident attributed to a superheater failure (image taken from Figure 17). The OCIM cloud is darker than the East Hope cloud.

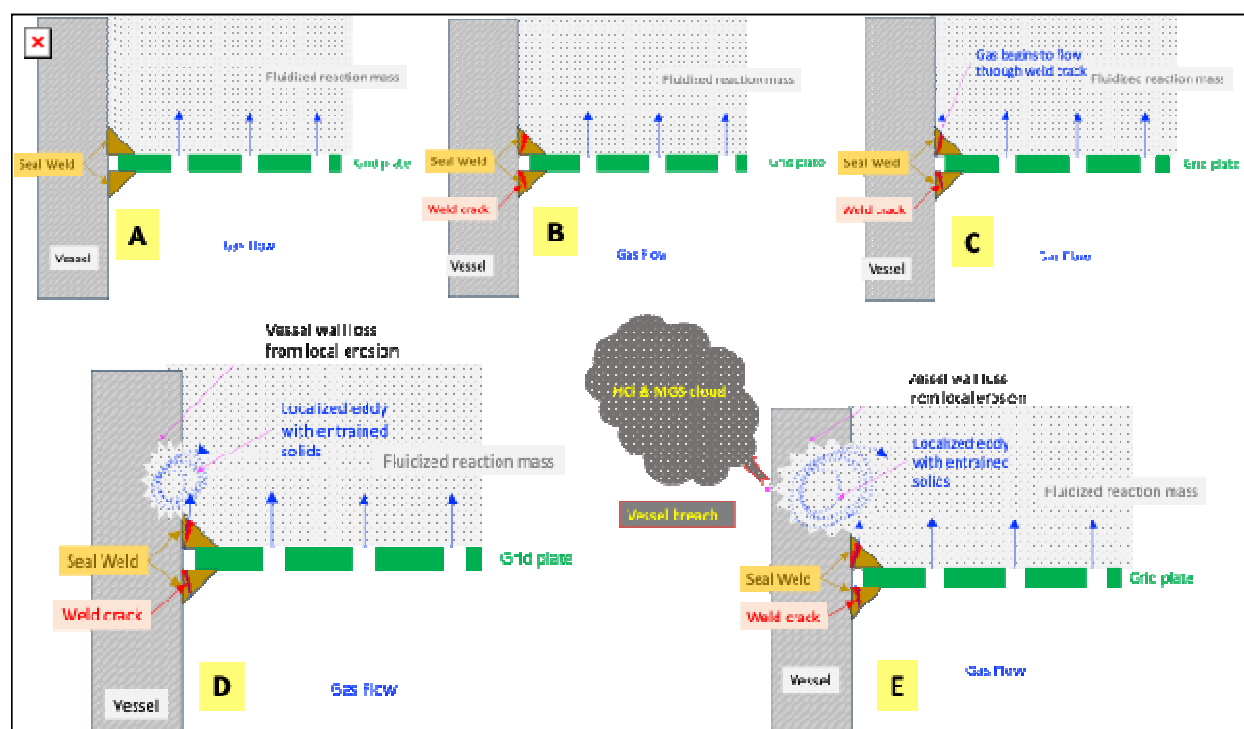
Figure 24 shows a simplified HC vessel failure that is initiated by a mechanical design where the grid plate is only seal welded to the vessel. Figure 24 shows a flat grid plate; the HC vessel failure can also occur with a conical grid plate attached to the vessel by seal welding.

Figure 24: Progression of HC vessel failure due to use of mechanical design with grid plate attachment to the HC vessel by seal welding.

Until the vessel breach actually occurs, there is no early warning / indication of the pending failure. If the hole / leak is quickly discovered by operating personnel either by routine walk-through checks of the unit or remote monitoring via video cameras, a rapid but controlled shutdown of the HC unit should be possible (pressure reduction being the important activity) and the de-pressure / de-inventory of the HC FBR minimized. If the leak is not quickly detected, the size of the hole can quickly grow due to localized abrasion of the vessel wall by impingement of abrasive reaction mass. There is a chance to have an accident of the magnitude experienced by OCIM in August 2024.
