OCIM August 2024 Fatal Accident Analysis

Alan Crawford
Bozeman, Montana
USA

Summary

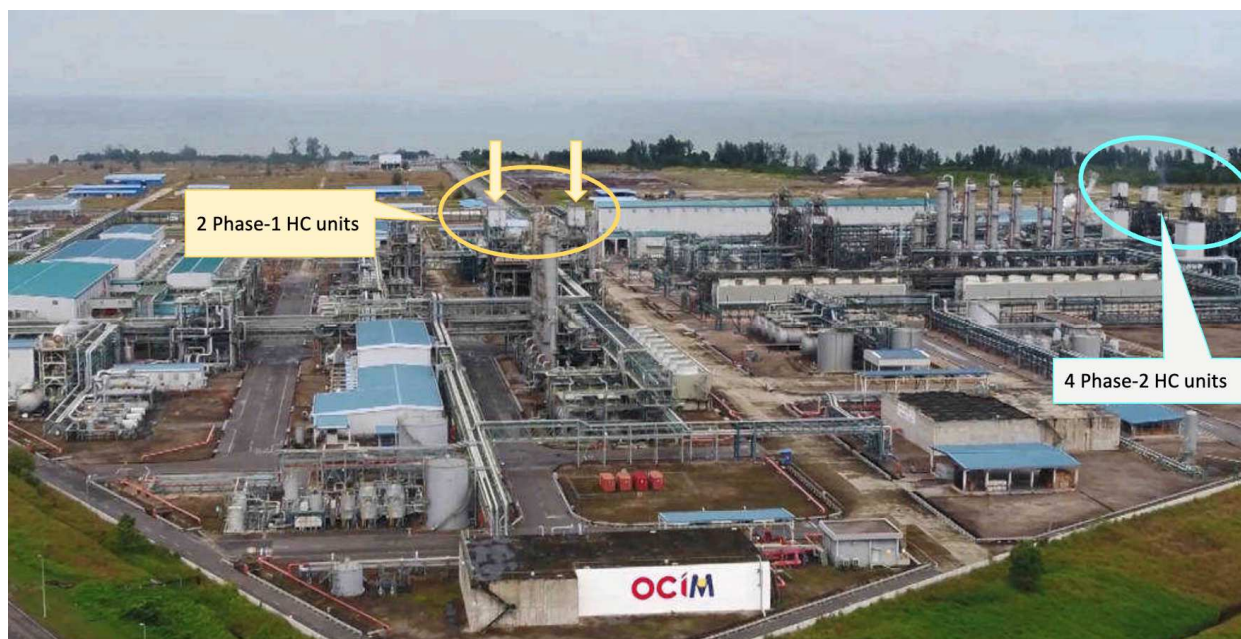
Figure 8: OCIM site with Phase-1 and Phase-2 identified. Note the unique configuration of the six HC units: two in Phase-1 and four in Phase-2.

The additional analysis shows with a high degree of confidence that the 14-August-2024 accident occurred in one of the four original HC units associated with the original Tokuyama Phase-2 plant. Figure 1 and Figure 6 clearly show three HC units as evidenced by the enclosed MG-Si feed system (rectangular light-colored enclosure) located above the top of the HC reactors. Figure 8 shows the two HC units of Phase-1 (near the center of the photo) and the four HC units of Phase-2 (background on the right corner of the photo). One can conclude with 100% certainty that the three HC units visible in Figure 1 and Figure 6 are from Phase-2. The fourth HC unit is not visible.

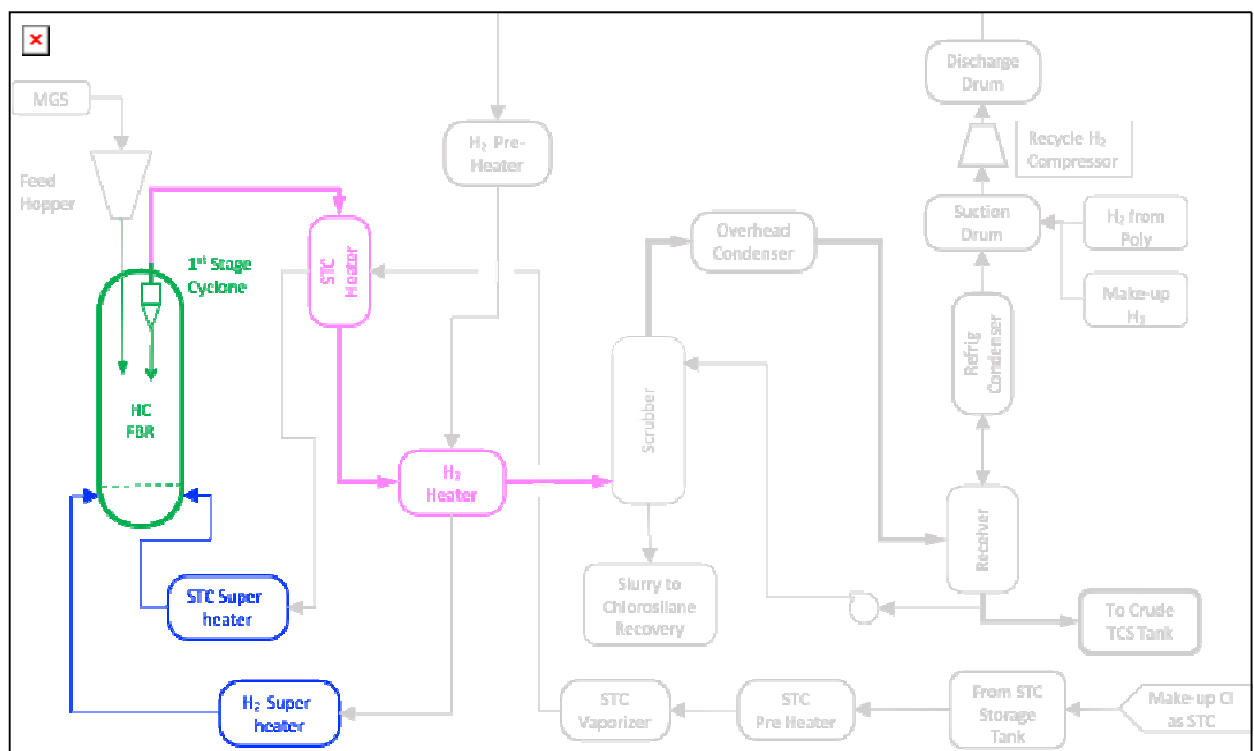
Figure 14 Block flow diagram of the Union Carbide **pilot** Hydrochlorination process unit used to produce TCS for production of silane (SiH_4). **Note the separate feeds of H_2 and STC to the HC reactor.** Anhydrous HCl co-feed is not required for a silane plant. The **green** highlighted equipment show use of Incoloy 800H based directly on Union Carbide corrosion studies with the system H_2 – STC – MGSi (these are the reactants fed to the HC reactor). The **magenta** highlighted equipment shows use of Incoloy 800H in a similar system as the HC reactor. The **blue** highlighted areas used Incoloy 800H but represent pure components (H_2 and STC) with limited corrosion concern. The **gray** sections do not use Incoloy 800H.

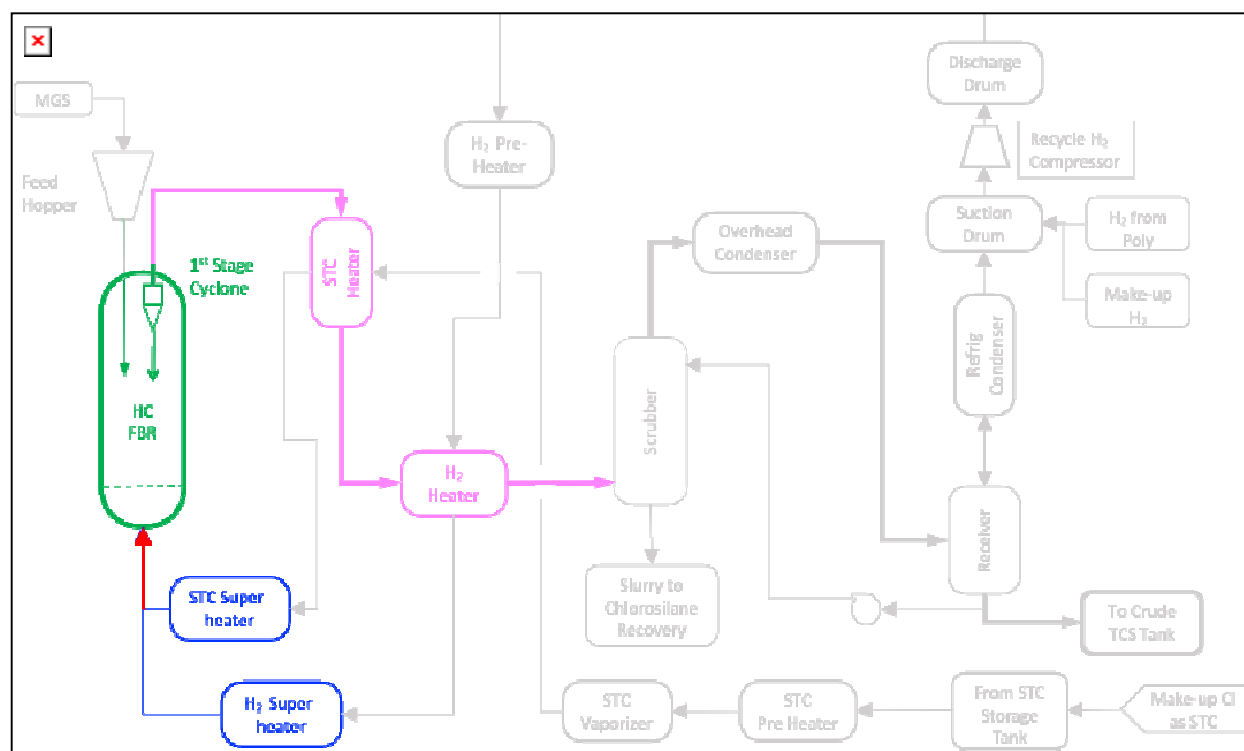
Figure 15 Block flow diagram of the Union Carbide industrial Hydrochlorination process unit used to produce TCS for production of silane (SiH_4). Anhydrous HCl co-feed is not required for a silane plant. The green highlighted equipment show use of Incoloy 800H based directly on Union Carbide corrosion studies with the system H_2 – STC – MGSi (these are the reactants fed to the HC reactor). The magenta highlighted equipment shows use of Incoloy 800H in a similar system as the HC reactor. The blue highlighted areas used Incoloy 800H but represent pure components (H_2 and STC) with limited corrosion concern. The red highlighted area shows use of Incoloy 800H for the H_2 – STC system which is not supported by any corrosion studies. The gray sections do not use Incoloy 800H.

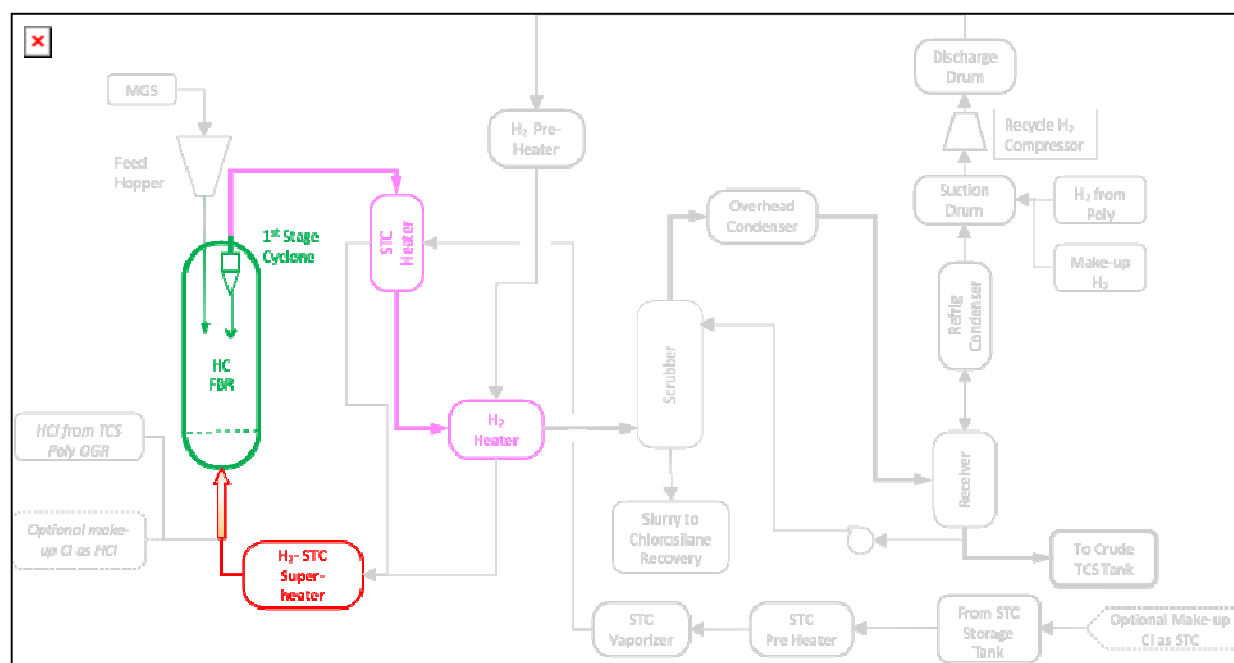
Figure 16. Block flow diagram of the most common industrial Hydrochlorination process unit used in current (late 2024) large capacity TCS-based Siemens polysilicon plants. The **green** highlighted equipment show use of Incoloy 800H based directly on original Union Carbide corrosion studies with the system H_2 – STC – MGSi (these are the reactants fed to the HC reactor). The **magenta** highlighted equipment shows use of Incoloy 800H in a similar system as the HC reactor. The **red** highlighted area shows use of Incoloy 800H for the H_2 – STC system which is not supported by any corrosion studies. The red-orange highlighted area shows the use of Incoloy 800H for the H_2 – STC – HCl system which is not supported by any published corrosion studies. The **gray** sections do not use Incoloy 800H.

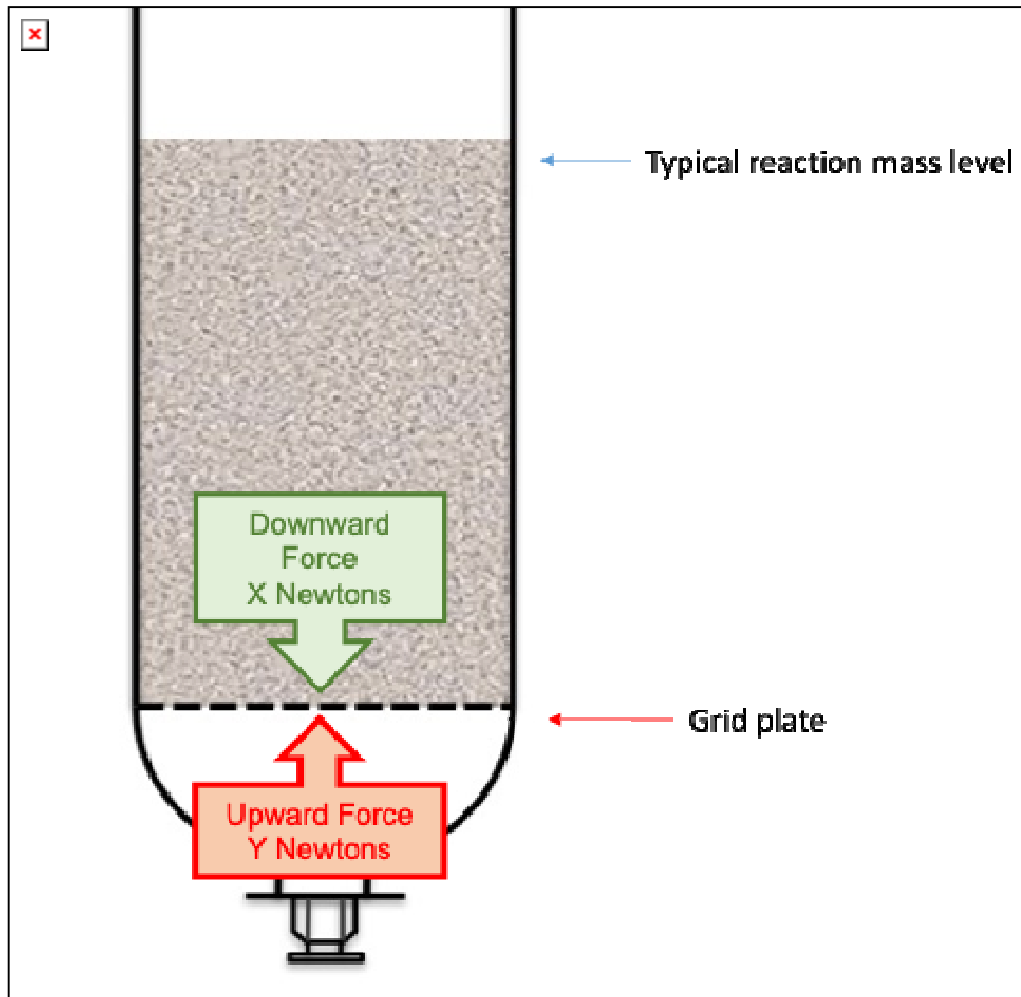
A very common design flaw observed in many industrial HC reactors is improper design of the grid plate attachment. While most designs properly account for the downward force, the same is not true for the upward force. The resulting mechanical design is for a grid plate that is only seal welded to the vessel. When horizontal support beams are used for larger diameter reactors having flat grid plates, some proposed designs have not even included seal welding the grid to the support beams. If the grid plate is only seal welded to the vessel and perhaps just resting on the horizontal support beams, **a serious HC vessel failure mode has been enabled**. Figure 23 shows a typical HC FBR with combined downward and upward forces.

Figure 23: Typical HC FBR showing combined downward and upward forces that must be considered in the design of grid plate attachment to the HC vessel. The total downward force is usually based on “full inventory” of non-fluidized reaction mass. The total upward force is usually based on maximum discharge pressure that can be achieved by the recycle H_2 compressor. Specific values of the downward and upward forces are not provided; these are considered trade secrets.
